# **Navajo Abandoned Uranium Mine**

## **Site Screen Report**

### **Brodie 1 AUM Site**

**August 2010**

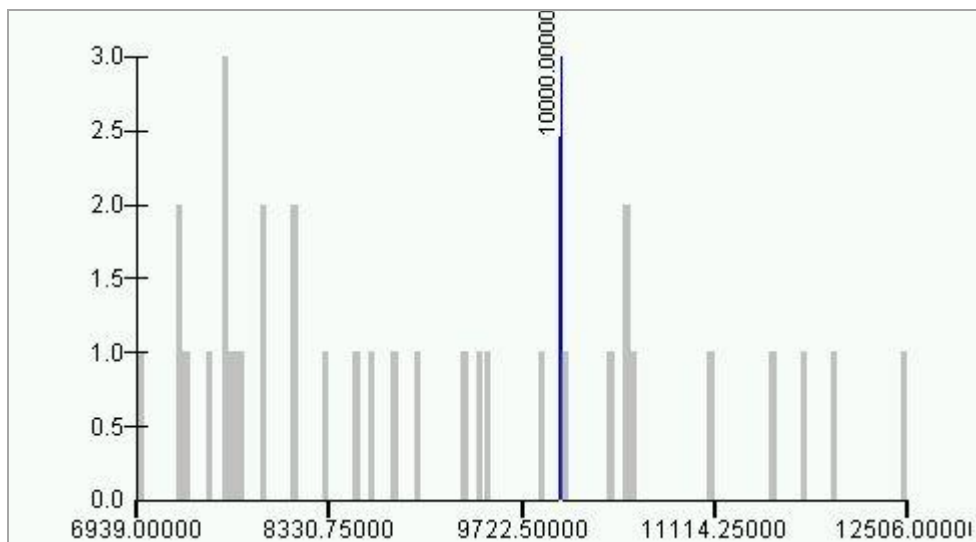
The following chart and statistics were generated by ESRI ArcGIS 9.3.1, and show the general distribution of the site gamma radiation measurements. The horizontal X axis represents the gamma radiation reading levels in cpm (lowest levels to the left). The vertical Y axis represents the frequency of each gamma radiation level.

Count:	33
Minimum:	6939.00000
Maximum:	12506.00000
Sum:	298127.00000
Mean:	9034.15152
Median:	8646.00000
Standard Deviation:	1565.06457

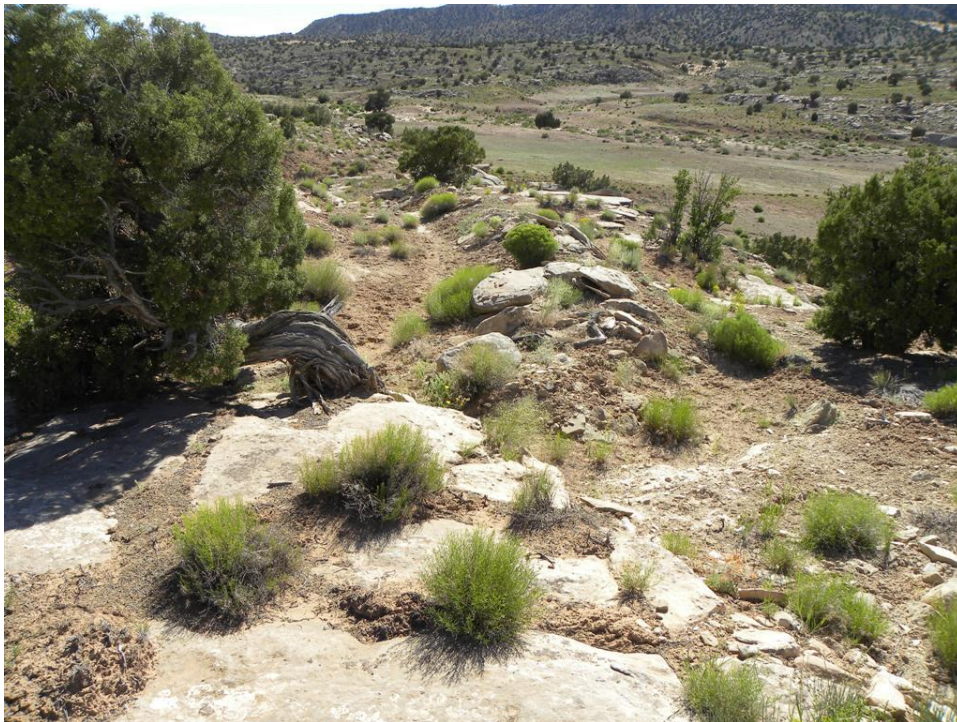
Photo 2. Brodie 1 site, berm area

Small rock-berm area W end of site

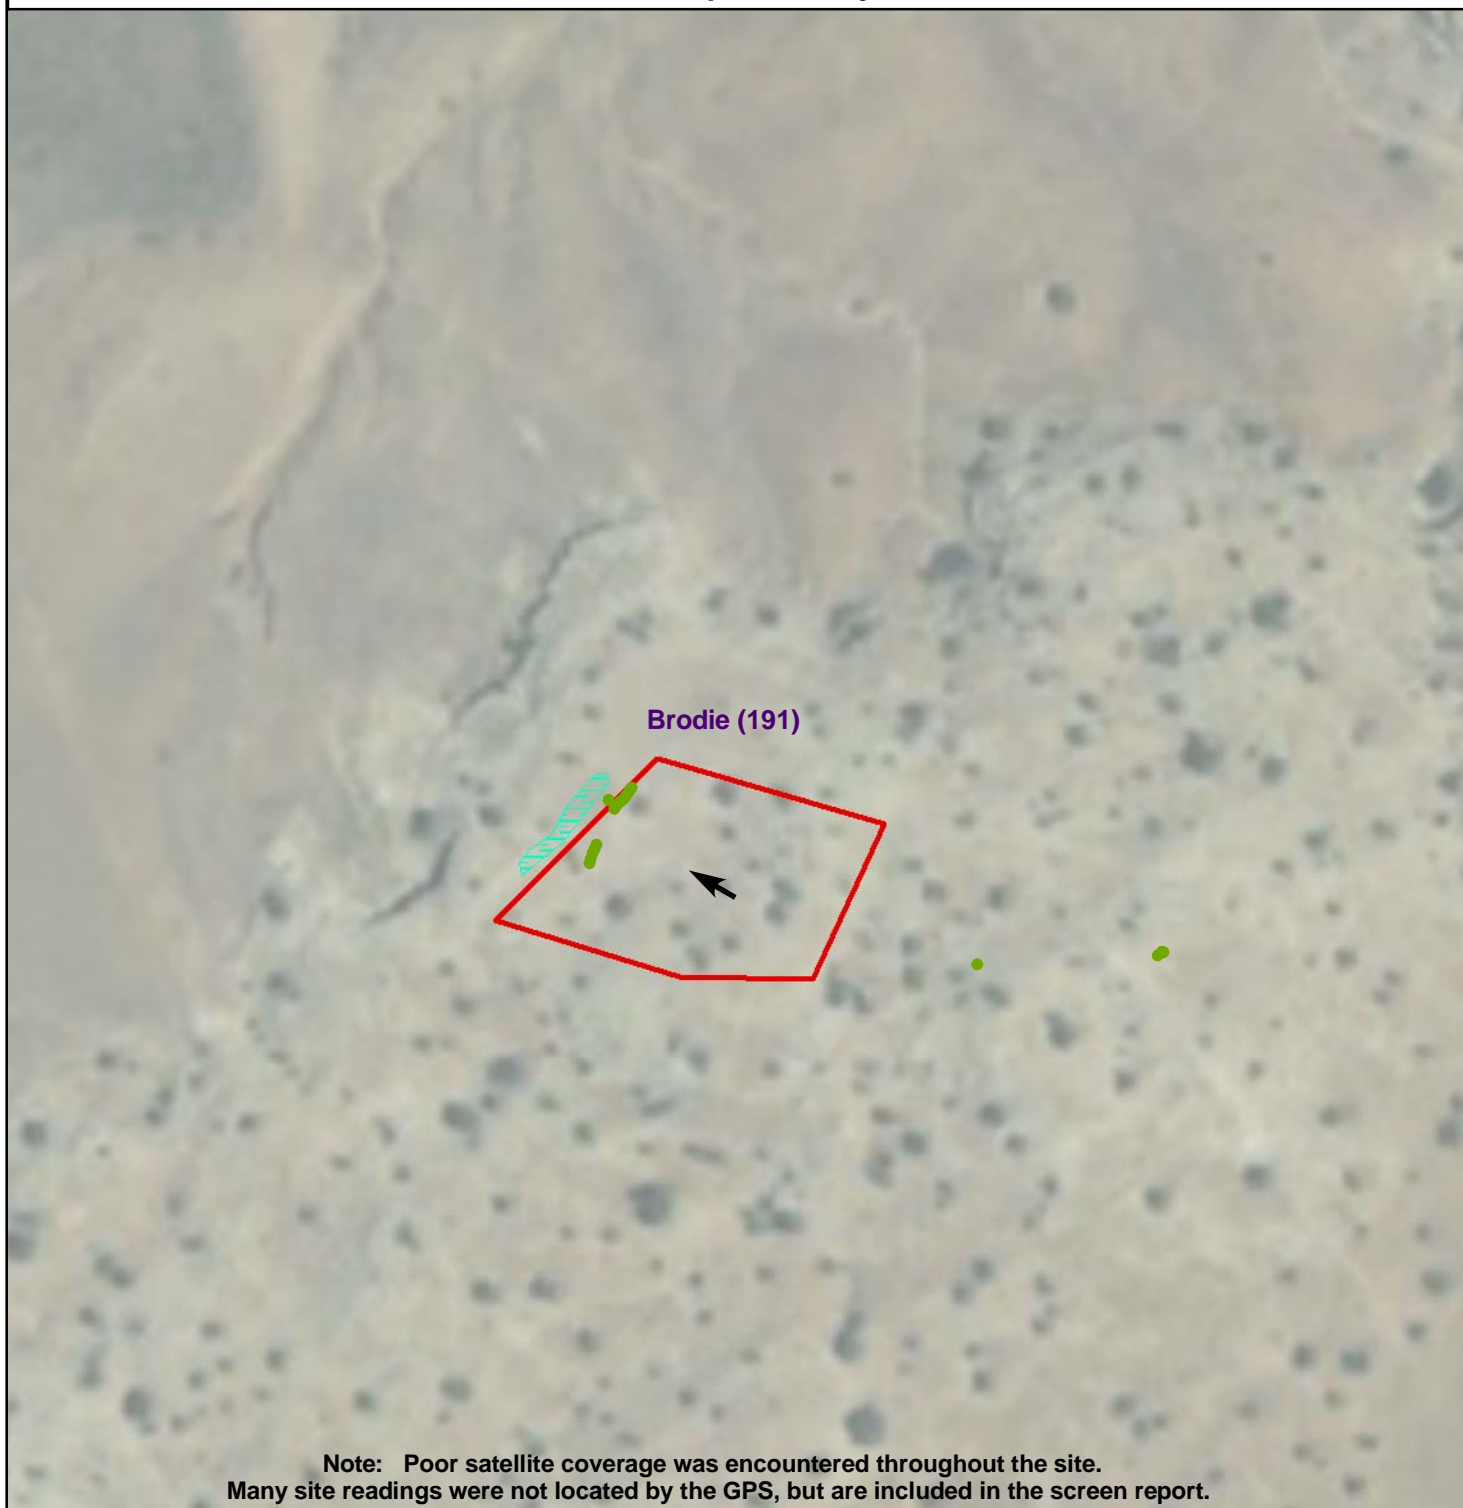
**Figure 1 - Gamma Radiation Measurements, Above Two Times Background  
Brodie (191)  
Red Mesa Chapter, Navajo Nation**

A total of 33 gamma radiation measurements were collected from the mine site, ranging from 6,939 cpm to 12,506 cpm. The measurements are represented in Figures 1 and 2.

Gamma survey conducted 06/2010  
Measured as counts per minute (cpm)

Average background = 7,709 cpm

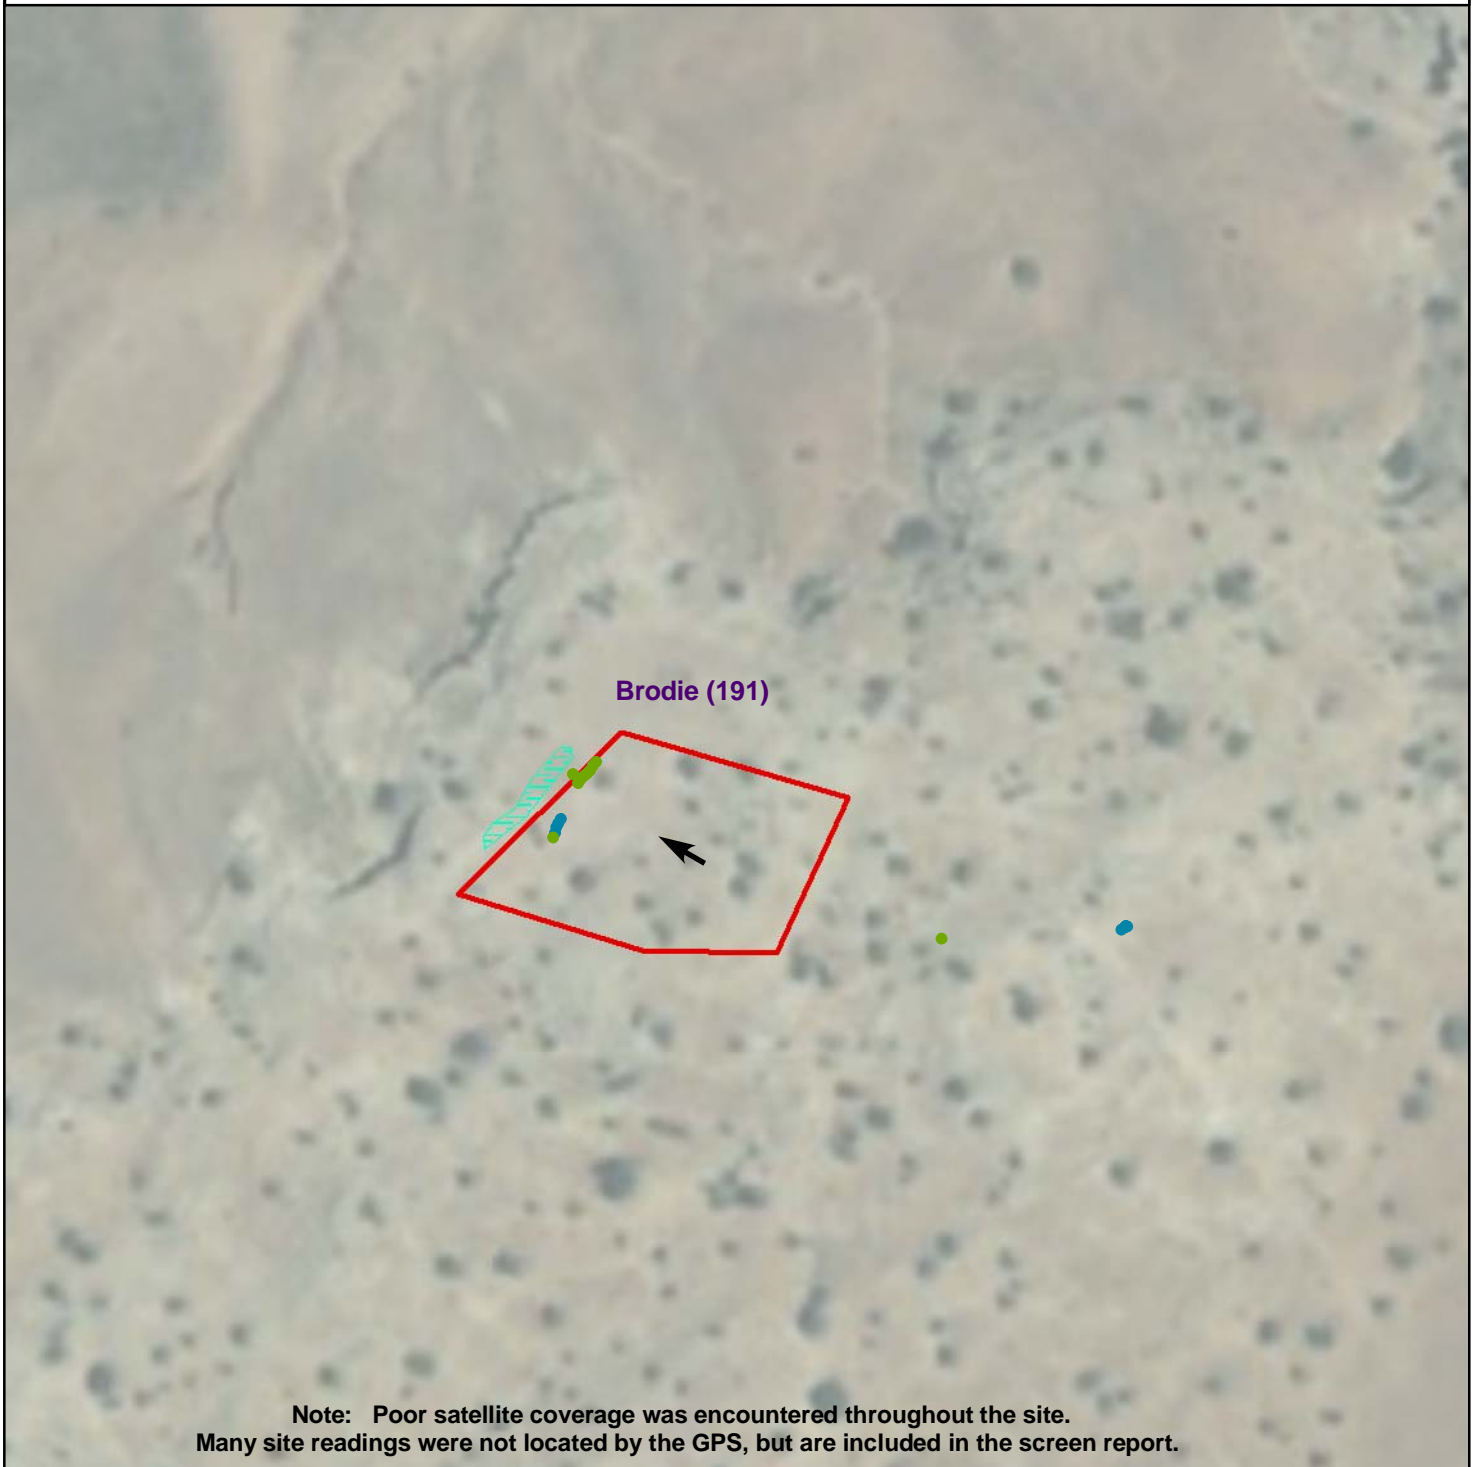
**Figure 2 - Gamma Radiation Measurements  
Brodie (191)  
Red Mesa Chapter, Navajo Nation**

**Gamma survey conducted 06/2010  
Measured as counts per minute (cpm)**

**Average background 7,709 cpm**
